Footers to Finishes, LLC

IAC2 Complete Mold Inspection Report

222 Anywhere Street, Sometown, West Virginia 26500
Inspection prepared for: Jack Homeowner
Real Estate Agent: Joe Broker - Realtord R Us

Date of Inspection: 4/20/2015 Time: 9:00 AM
Age of Home: Built in 1966 Size: 2010
Weather: 58F Overcast
The home faces east.

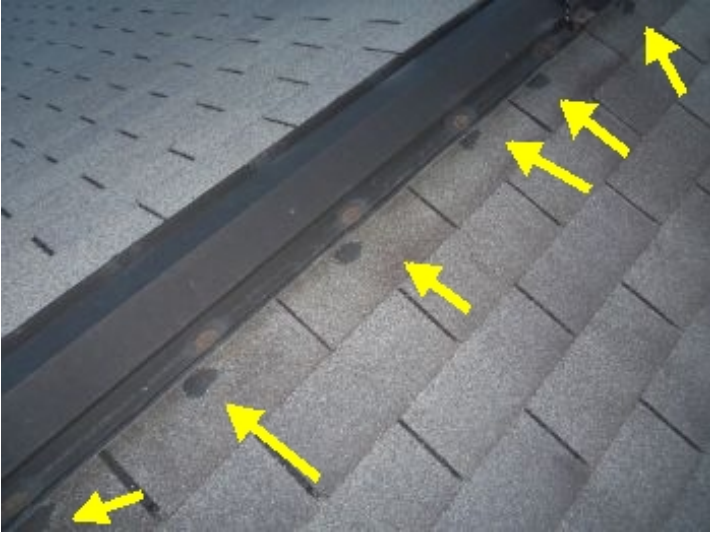
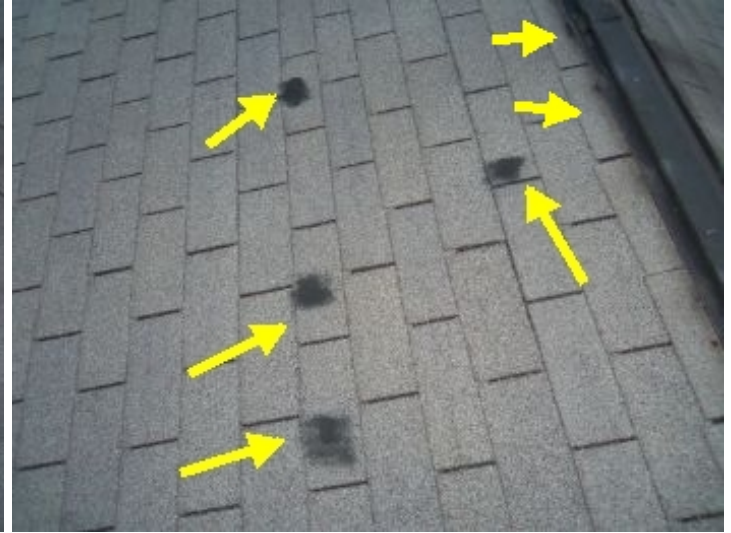
Observations: Slightly weathered. Exposed nail heads along the top course of shingles just below the ridge cap.

exposed fasteners

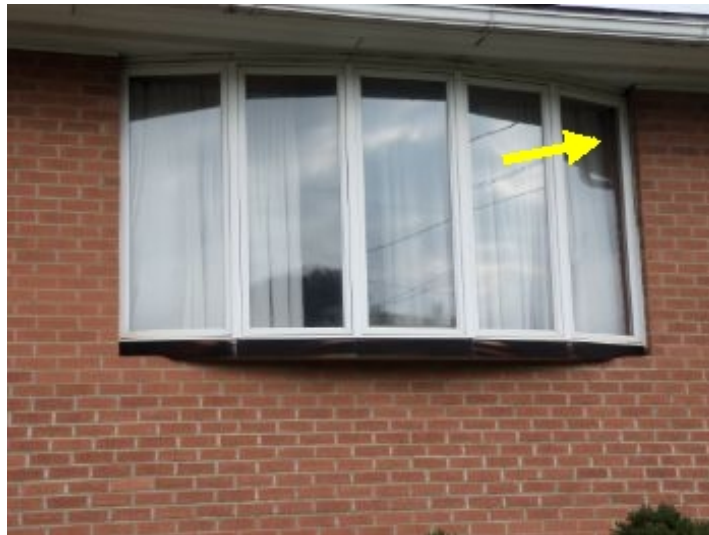
- The caulking for the bay window in the front of the home is deteriorating recommend re-caulking to alleviate any moisture penetration. No discrepancies noted with the other exterior features within this section.

Bay window needs caulking repaired

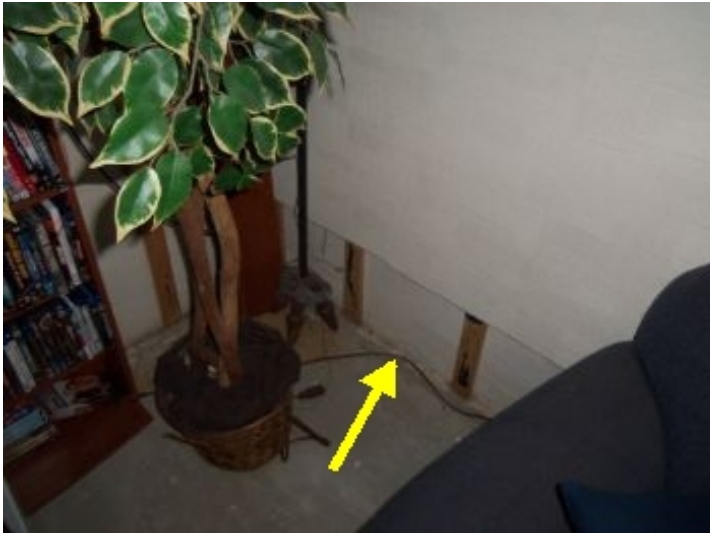
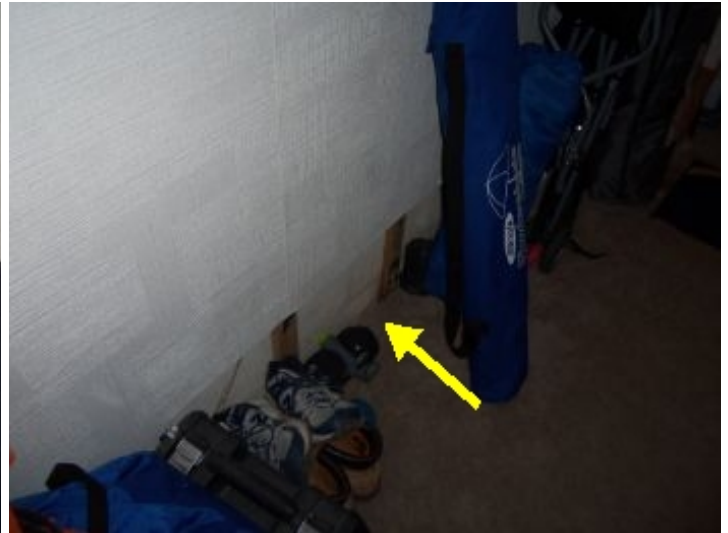
• There appears to be past water penetration in the basement. Approximately 12 inches of drywall has been removed from the bottom of the finished basement walls. Some apparent microbial growth was noted along the bottom of the wall. One air sample and one lift sample were taken from the basement family room on March 24, 2015 and sent for laboratory testing.

removed drywall from basement wall

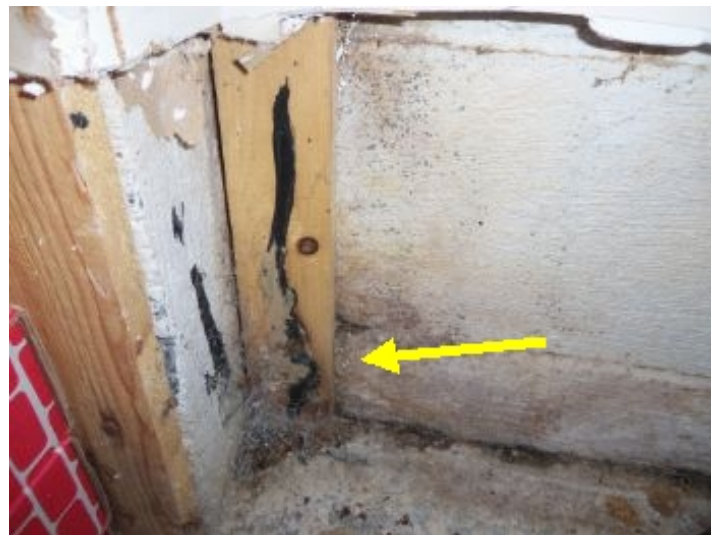
• There does not appear to be any active moisture intrusion, however, there appears to be prior moisture damage to the bottom of the furring strips on the exterior walls.

moisture damage to furring strip

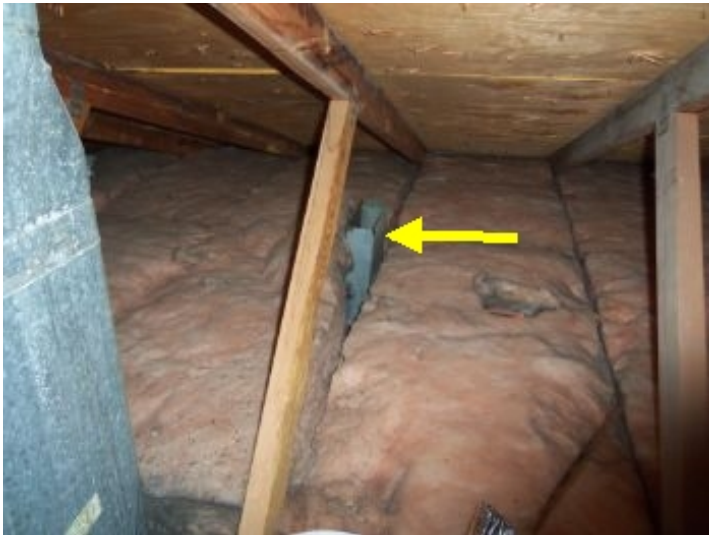
- There are ridge and soffit vents noted.
- The exhaust fans from the range hood and bathrooms are venting directly into the attic. I recommend extending the exhaust ductwork to the exterior to avoid future moisture problems.

exhaust duct terminating in attic

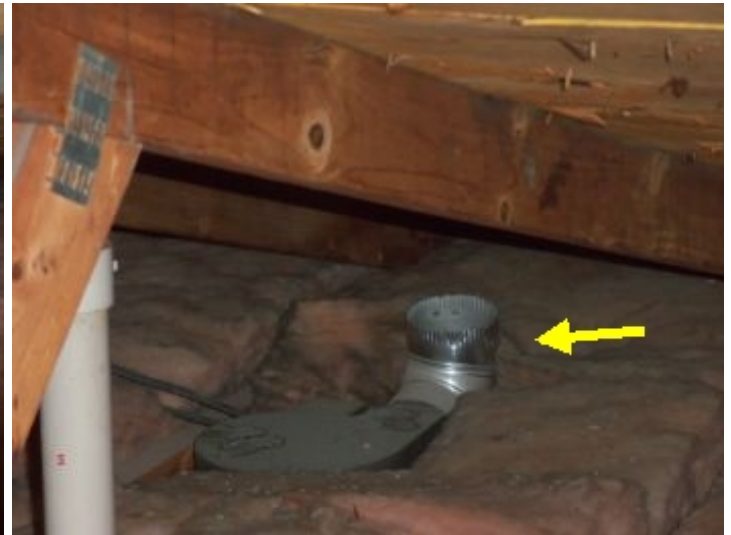
bathroom ventilation exhaust terminating in attic

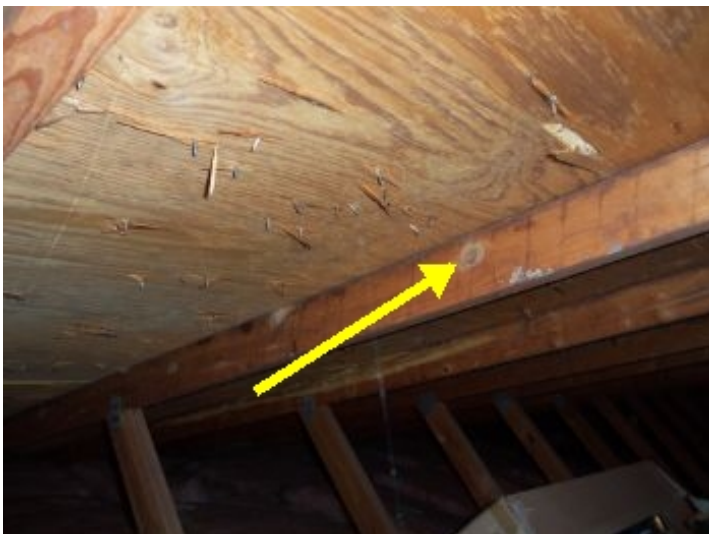
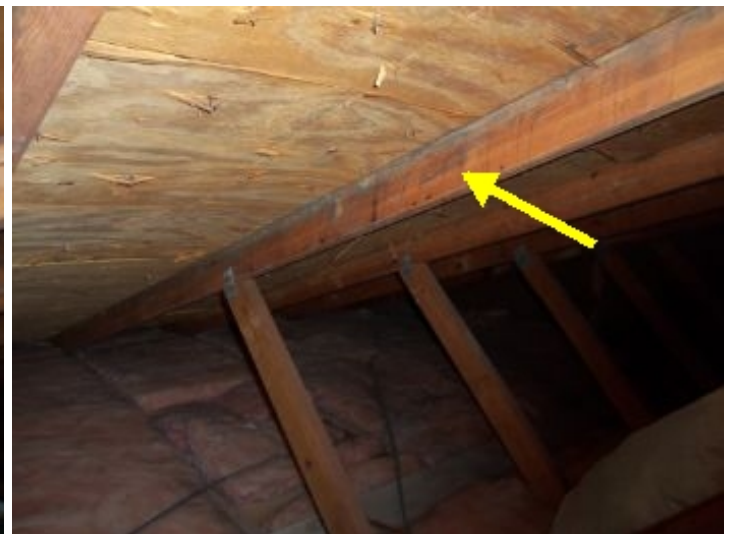
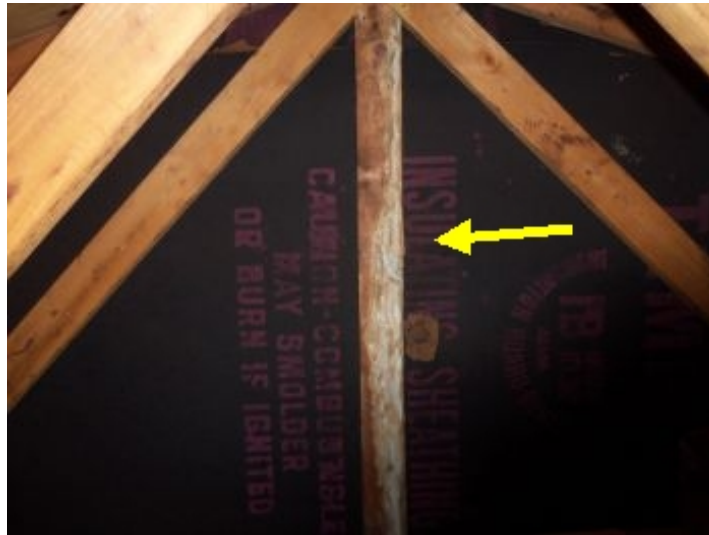
- Pre-engineered truss construction noted. Evidence of past water intrusion noted. Area dry at time of inspection.

evidence of past water penetration

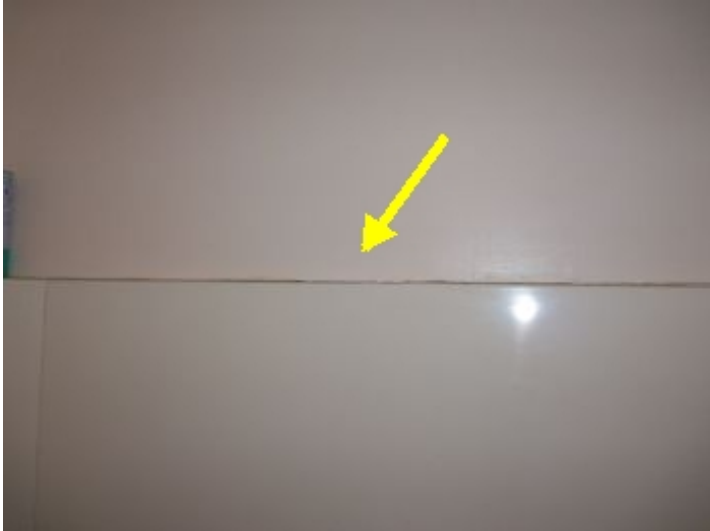
- There is a water stain on the ceiling adjacent to the attic access stairs. The bathroom ceilings have apparent water damage to the tape joints where the ceiling intersects the wall.
- The top of the shower surrounds need to be re-caulked to prevent moisture from getting behind the shower.

damaged caulking above shower

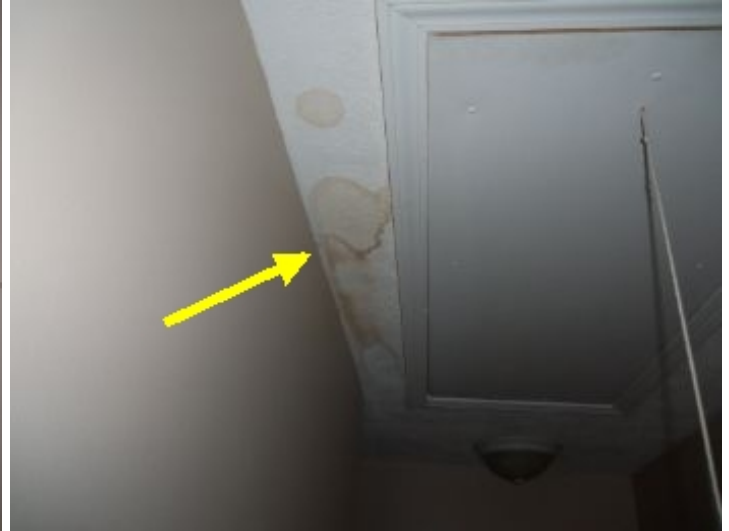
past water stain on ceiling by attic access

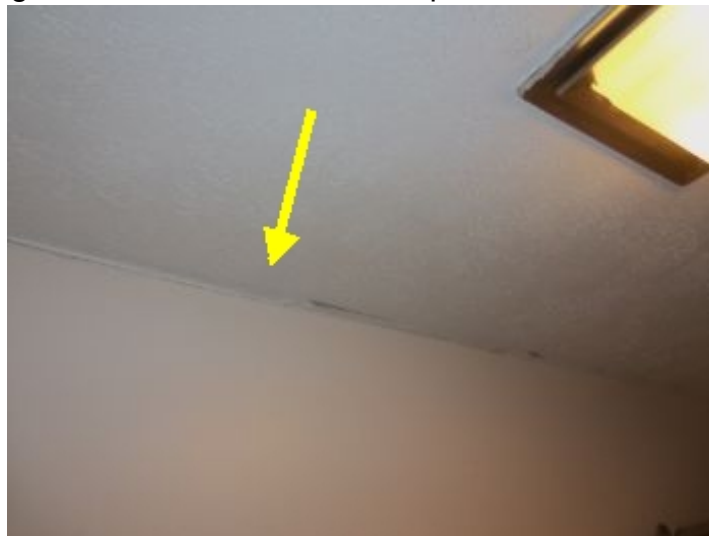
tape joint moisture damage
